Beckfoot Upper Heaton School - Accessibility Action Plan.

Updated: 10/01/2025

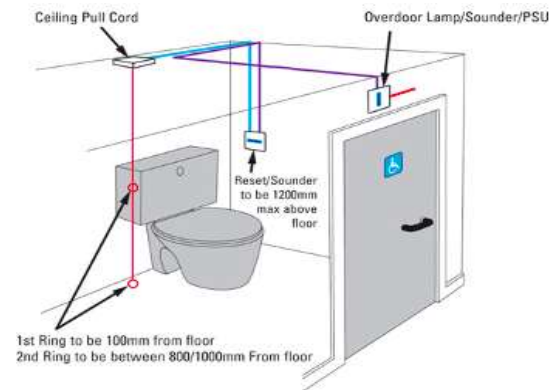
13.11

The cord alarm in reception was not freely hanging within a suitable distance of the floor.

The cord alarm on the first-floor facility was marginally high from ground floor level.

The cord alarm in the hygiene room was looped around a grab rail.

The cord alarm in the facility near to the dining area was marginally high from ground floor level.

If cord alarms are not hanging within a suitable distance of the floor, distress calls may go unnoticed.

According to BS8300 - An emergency assistance pull cord should be sited so that it can be operated from the WC and from an adjacent floor area. The emergency assistance pull cord, coloured red, should be provided with two red bangles of 50 mm diameter, one set at a height between 800 mm and 1000 mm and the other set at 100 mm above floor level.

Implement a management procedure to ensure that cord alarms are always kept loose and not tied up.

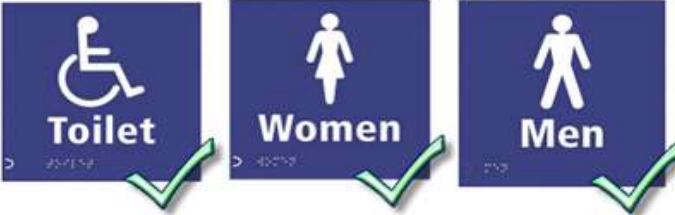
<p>15.3</p>	<p>The accessible WC facility in reception was not signposted.</p> <p>The accessible WC on the second floor was not signposted as an accessible WC facility.</p> <p>The accessible WC opposite F.06 was not signposted as an accessible WC facility.</p> <p>The signage provided to the first floor, male and female staff facilities opposite F.22 were entirely capital letters.</p> <p>The signage for the student male facility on the first floor was broken.</p> <p>The Hygiene Room was not signposted.</p> <p>The accessible WC facility by the dining area did not feature signage.</p> <p>The WC facility by sports was not suitably signed.</p>	<p>The appropriate toilet signage should be provided. As well as signage on the toilet doors, there should also be signs indicating where the accessible WCs are located.</p> <p>BS8300 states - Information and direction signs should be provided at each point where they are required, e.g. at junctions of circulation routes, at key locations such as doorways and reception points, at facilities such as telephones and toilets, and in rooms, spaces and counters. The colour, design and typeface of signs should be consistent throughout a building.</p> <p>All accessible WC door signage to be accessible to all disabled people with Braille and embossed lettering preferred.</p>

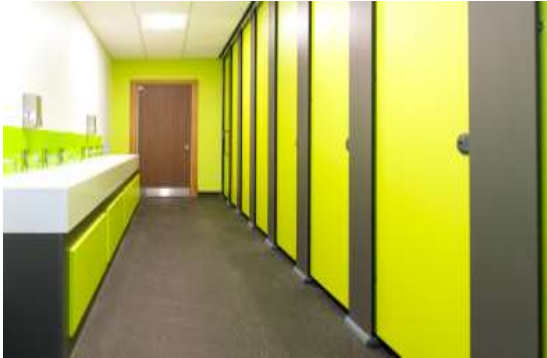
<p>12.4</p>	<p>The compartment doors for the student WC facilities were not well contrasted against the frames.</p>	<p>Cubicle doors throughout should appropriately colour contrasted to identify doors within frames to aid people with impaired vision. A difference of 30 points LRV (Light Reflectance Value) is recommended as appropriate contrast.</p>

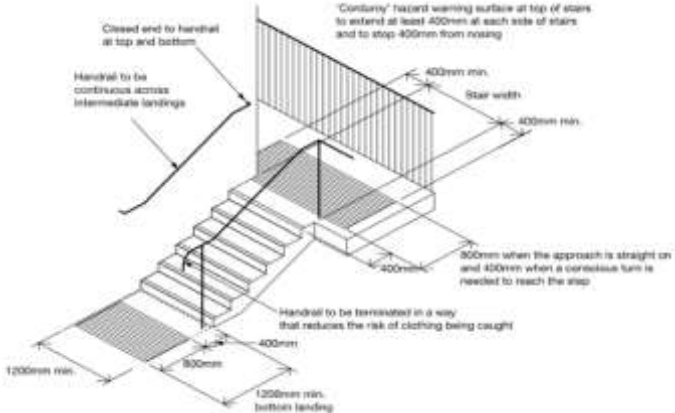
<p>4.1</p>	<p>Tactile paving was provided to the main external steps that lead towards the school.</p> <p>The tactile paving provided to the steps that lead toward the school field featured tactile paving, but these were directly next to the step, rather than the recommended 400mm distance away from the final step.</p> <p>A set of stairs were identified close to the sports hall, within the car park. These steps did not feature tactile paving. The auditor was informed that these steps were not used.</p>	<p>Ensure that tactile paving is appropriately positioned by the external steps, 400mm from the foot landings.</p> <p>BS8300 - To give advance warning of a step, tactile paving with a corduroy hazard warning surface should be provided at the top and bottom of each flight, excluding intermediate landings with continuous handrails. Where the approach to the stair is wider than the flight, the tactile surface should extend beyond the line of each edge of the flight.</p>

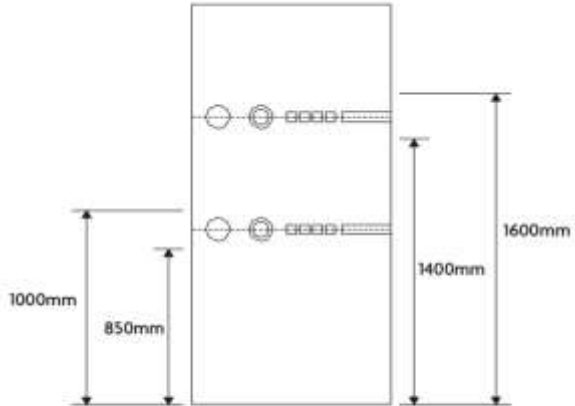
<p>5.1</p>	<p>The main entrance to the school was clearly signposted; however, the entrance doors were not clearly visible from the surrounding frames. Contrast could assist people who are partially sighted towards the main entrance.</p>	<p>Colour contrast should be added to the entrance to ensure that it is clearly visible on approach to aid people with impaired vision.</p> <p>AD M - The presence of the door should be apparent not only when it is shut but also when it is open. Where it can be held open, steps should be taken to avoid people being harmed by walking into the door.</p>	<p>M</p>	
<p>5.9</p>	<p>The entrance doors featured manifestations at two heights. The lobby door to the main entrance featured one door with no manifestations. This could be a collision hazard.</p>

<p>Manifestation can take various forms, e.g. broken or solid lines, patterns or company logos</p>	<p>Well contrasted manifestations should be provided at two heights to both doors at the lobby entrance.</p> <p>Glazed doors need to have permanent strips on the glass within two zones, from 850mm to 1000mm from the floor and from 1400mm to 1600mm from the floor. These strips need to be contrast in colour (not treated glass) and luminance with the background seen through the glass in all light conditions.</p>	<p>M</p>
